DEPARTMENT OF TRANSPORTATION**DIVISION OF ENGINEERING SERVICES**

Contract #: 04-0120F4Cty: SF/ALA Rte: 80 PM: 13.2/13.9File #: 69.28**WELDING INSPECTION REPORT****Resident Engineer:** Pursell, Gary**Address:** 333 Burma Road**City:** Oakland, CA 94607**Report No:** WIR-004739**Date Inspected:** 23-Nov-2008**Project Name:** SAS Superstructure**OSM Arrival Time:** 1400**Prime Contractor:** American Bridge/Fluor Enterprises, a JV**OSM Departure Time:** 2300**Contractor:** Zhenhua Port Machinery Company, Ltd (ZPMC), Changxing Island **Location:** Shanghai, China**CWI Name:** Chao Chen Sun**CWI Present:** Yes No**Inspected CWI report:** Yes No N/A**Rod Oven in Use:** Yes No N/A**Electrode to specification:** Yes No N/A**Weld Procedures Followed:** Yes No N/A**Qualified Welders:** Yes No N/A**Verified Joint Fit-up:** Yes No N/A**Approved Drawings:** Yes No N/A**Approved WPS:** Yes No N/A**Delayed / Cancelled:** Yes No N/A**Bridge No:** 34-0006**Component:** Tower diaphragms**Summary of Items Observed:**

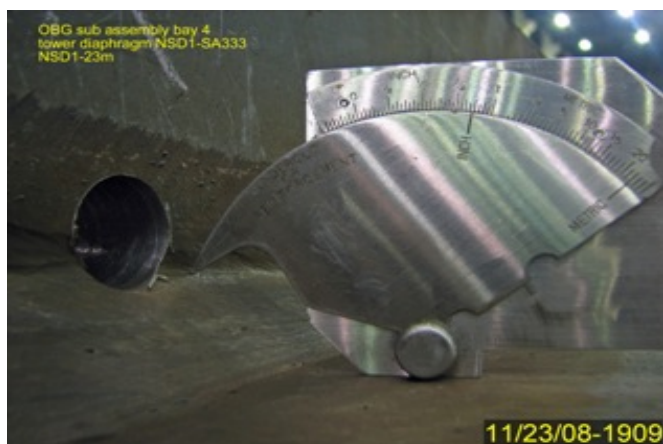
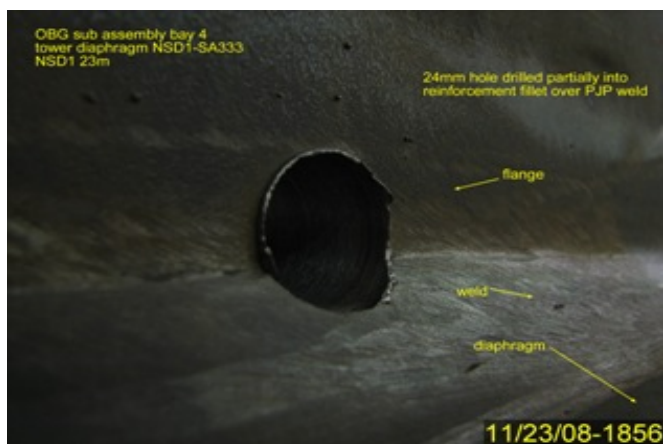
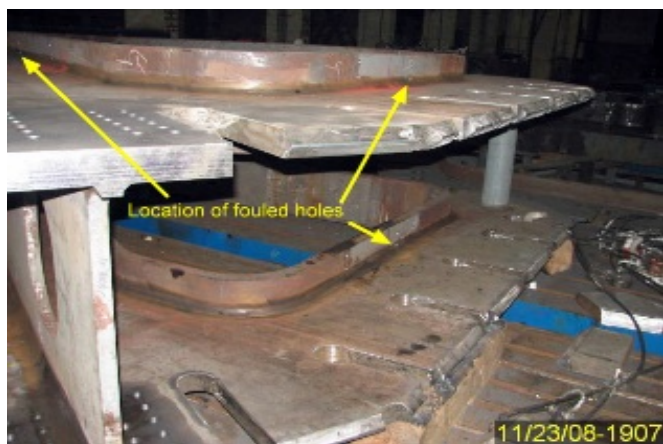
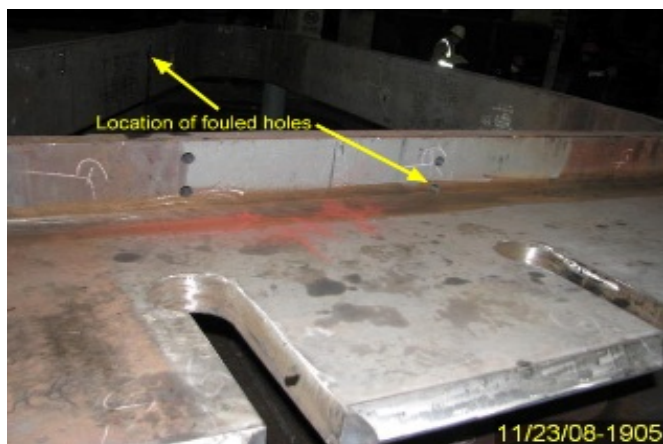
QA noted on the above mentioned tower diaphragm that holes were drilled through the inner flange and into the reinforcing fillet over the Partial Joint Penetration (PJP) weld joining the flange to the diaphragm. (See attached pictures) This condition exists in four locations on this diaphragm and four locations on tower diaphragm identified as WSD1-238 WSD1-23m. QA notified ZPMC QA Mr. Li Xiu Yang (Tom) of this condition. Mr. Yang said he would inform his leaders of this issue on Monday morning 11/24/08.
